Repairing Power Window Drive Units 60-64

by Merle Wolfer

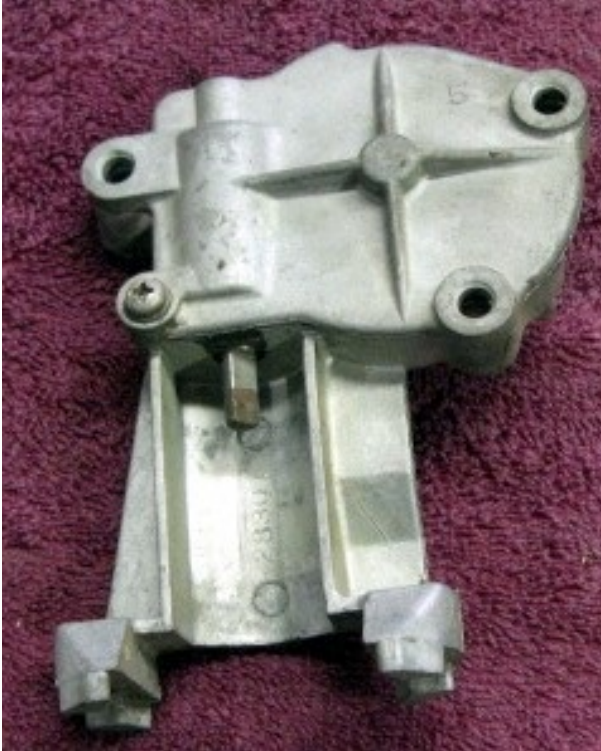
Chrysler Power Window Gear Drive used from 60 through 64. This one has a broken gear.

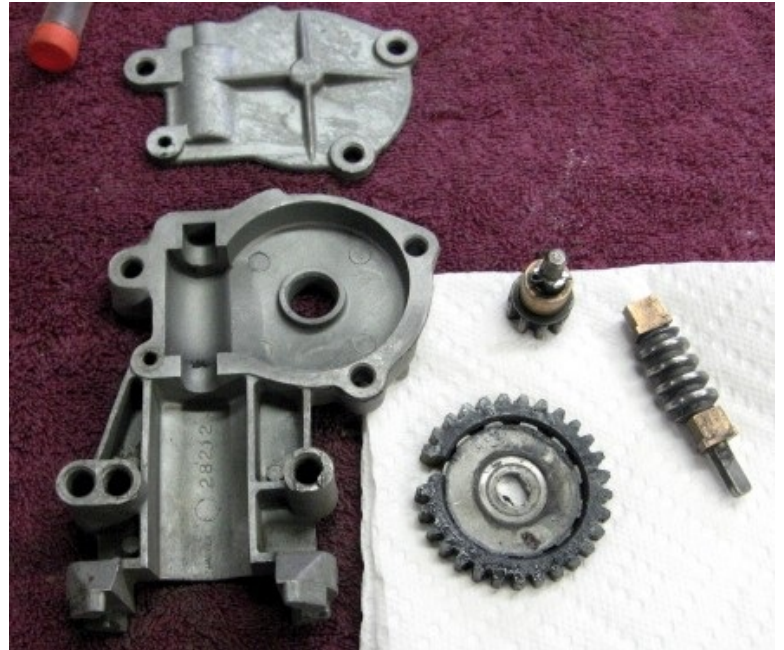
Here are all of the pieces when it is dismantled. The broken gear is bottom center.

The first thing was to decide how to get the unit apart. After removing the screw on the cover, the cover comes off. Inside, a worm gear sits in two bronze oillite bushings. The worm gear with bushings lifts out as a unit.

The smaller gear and shaft are a unit. There is another oillite bushing in the housing. Where the shaft extends through the housing it is rectangular shaped so that the large gear won't slip when it turns.

A bit of the rectangular shaft extends through the gear and its edges are peened so that the shaft won't pull out of the gear.

With my Dremel Tool and a small grinding wheel I ground off the excess peening and was able to remove the shaft with oillite bushing and small gear. I cleaned everything thoroughly as it was full of grease.

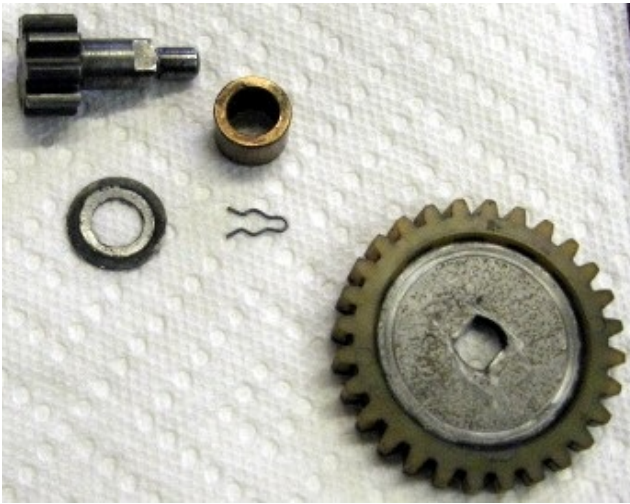
Gears and bushing shown with other pieces. Small clip in center was used in assembly. Large gear shown is replacement for broken unit.

When these come apart the oillite bushing wants to stay on the shaft with the small gear. When the top edge of the shaft is peened over it tends to slightly swell the rectangular part of the shaft so that the oillite bushing doesn't want to slide off.

I used a file to dress the edge of that area until the bushing slid off easily.

Using my Dremel again with the same grinding wheel I cut a groove in the shaft that protrudes from the gear housing.

The Dremel wheel cuts the right thickness to take a small spring clip shown in this page, top left photo.

In the photo above I wanted to show the pieces before I applied grease to it.

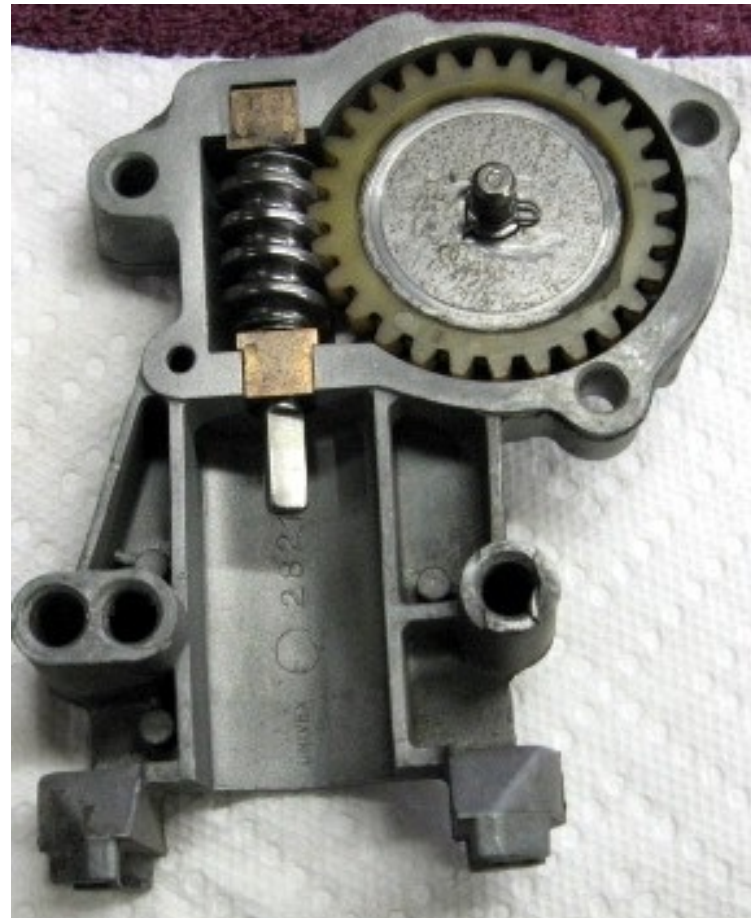
Reassembled unit shows spring clip on shaft and is ready to operate.

This allows it to be assembled with the spring keeper completing the repair. If it ever needs maintenance in the future it can be quickly dismantled for whatever service it needs.

At this point it can be lubricated, closed up and it should work just fine.
